# Bathymetric and Velocimetric Surveys at Highway Bridges Crossing the Missouri and Mississippi Rivers on the Periphery of Missouri, July–August 2018

By Richard J. Huizinga

Scientific Investigations Report 2020–5088

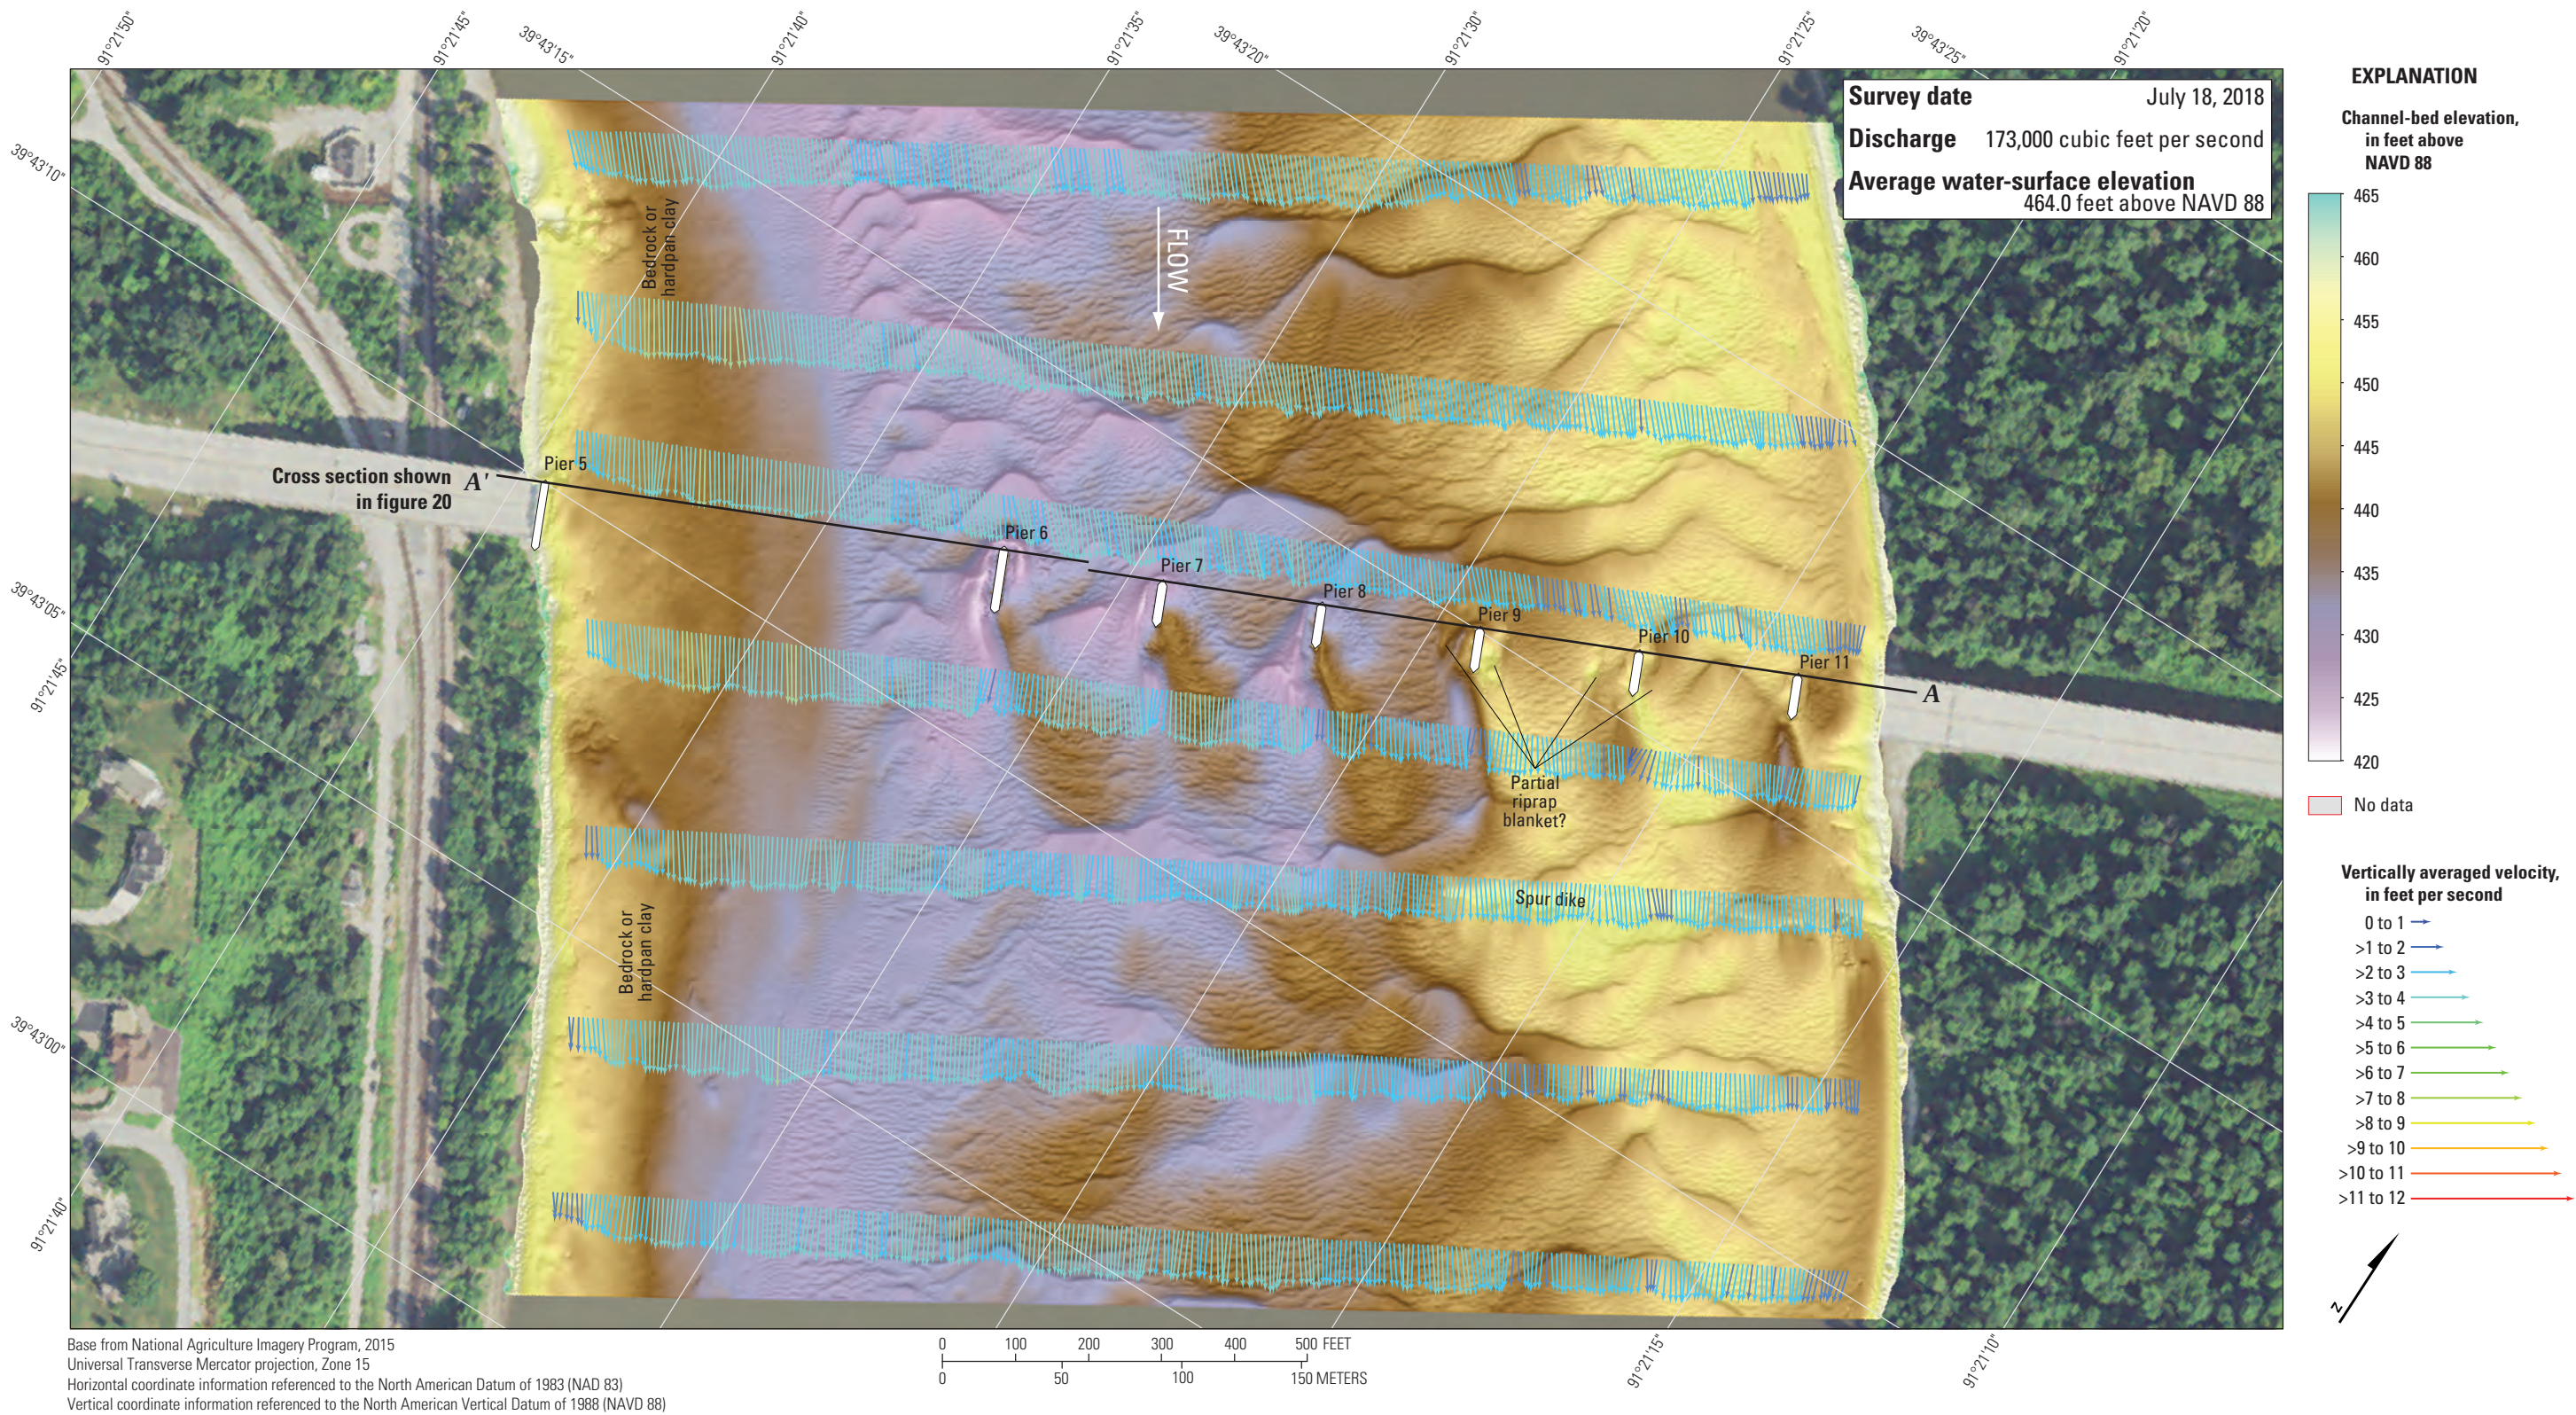
The vertically averaged velocity vectors indicate mostly uniform flow throughout most of the channel, ranging from about 3 to 7 ft/s (fig. 22). Areas of non-uniform flow caused by the skewed orientation of the piers is evident in the velocity sections downstream from the bridge, as well as near the spur dike on the left bank downstream from the bridge. Similar areas of non-uniform flow are apparent in the upstream sections as well, likely caused by a railroad bridge located about 1,130 ft upstream from the surveyed reach (fig. 22)

**Figure 22.** Bathymetry and vertically averaged velocities of the Mississippi River channel near structure A5054 on Interstate 72 at Hannibal, Missouri.

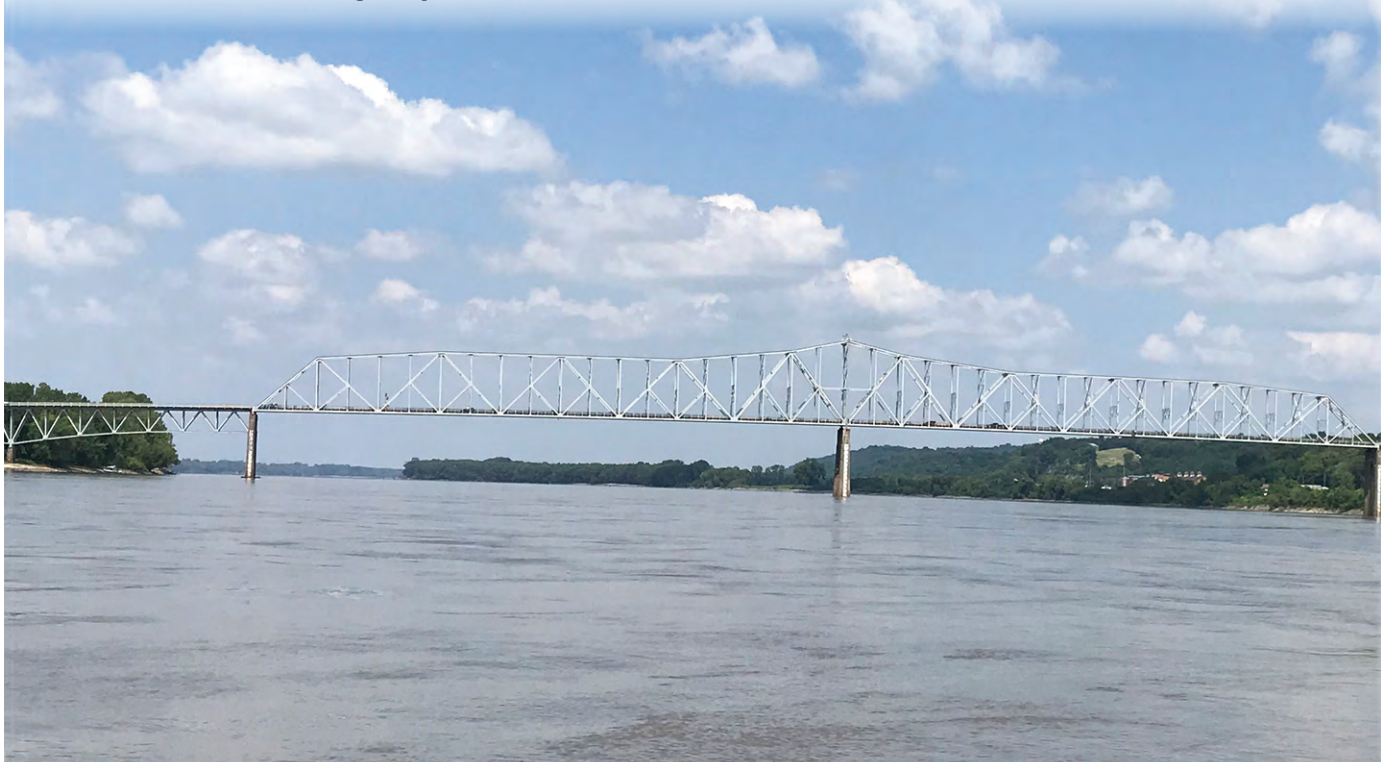
**Structure L0135 on State Highway 51**

Near pier 11 (fig. 23), a substantial scour hole had a minimum channel-bed elevation of about 306 ft (table 7), which is about 16 ft below the average channel elevation upstream from the pier (figs. 23, 25, 1.5C, 1.5D). Information from bridge plans (Missouri Department of Transportation, written commun., 2000) indicates that pier 11 is founded on a caisson on bedrock, having about 40 ft of bed material between the bottom of the scour hole and bedrock (fig. 25; table 7). Near pier 10 (fig. 23), a moderate scour hole had a minimum channel-bed elevation of about 330 ft (table 7), which is about 8 ft below the average channel elevation upstream from the pier (figs. 23, 25, 1.5E, 1.5F). Pier 10 also is founded on a caisson on bedrock, having about 85 ft of bed material between the bottom of the scour hole and bedrock (fig. 25; table 7). Pier 12 is founded on footings on the exposed bedrock on the right bank, with no apparent scour hole nearby (figs. 23, 25, 1.5A, 1.5B; table 7). Pier 13 also is founded on footings on the exposed bedrock on the right bank, and was near the surveyed water surface with no apparent scour hole nearby (figs. 23, 25; table 7). In modern construction, bridge substructural elements usually are pinned or socketed to bedrock (American Association of State Highway Transportation Officials, 2012; Brown and others, 2010), but full exposure of usually buried substructural elements warrants special consideration and

observation, even when designed to be exposed. The surveyed bed generally was lower than the original ground line from 1940 bridge plans (Missouri Department of Transportation, written commun., 2000) between piers 9 and 10 and between piers 11 and 13, and higher than the original ground line between piers 10 and 11 (fig. 25). The surveyed bed was approximately the same as the bed from the Level 2 scour survey in 2000 (Huizinga and Rydlund, 2004), except on the left bank (fig. 25); however, the ground line from the Level 2 bridge scour assessment was along the downstream side of the bridge and may have incorporated part of the downstream spur dike (fig. 23).

Figure 23. Bathymetric survey of the Mississippi River channel near structure L0135 on State Highway 51 at Chester, Illinois.

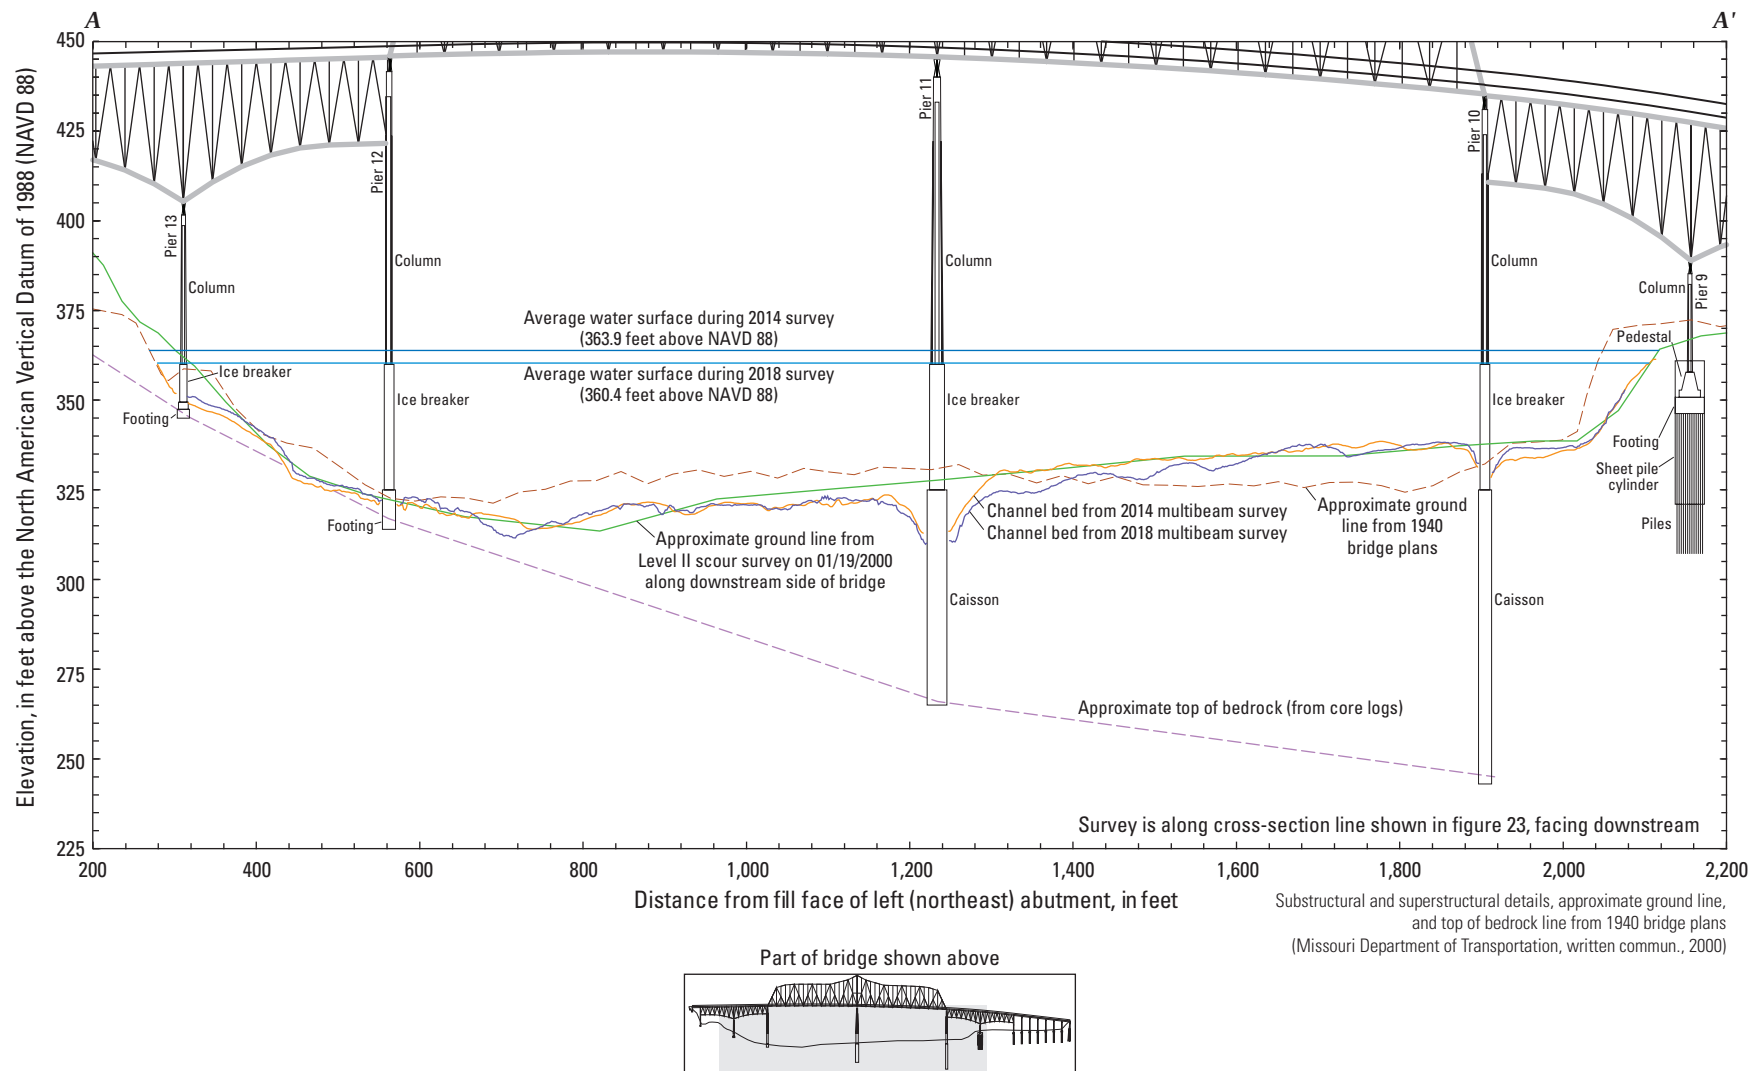
**Figure 25.** Key features, substructural and superstructural details, and surveyed channel bed of structure L0135 on State Highway 51 crossing the Mississippi River at Chester, Illinois.

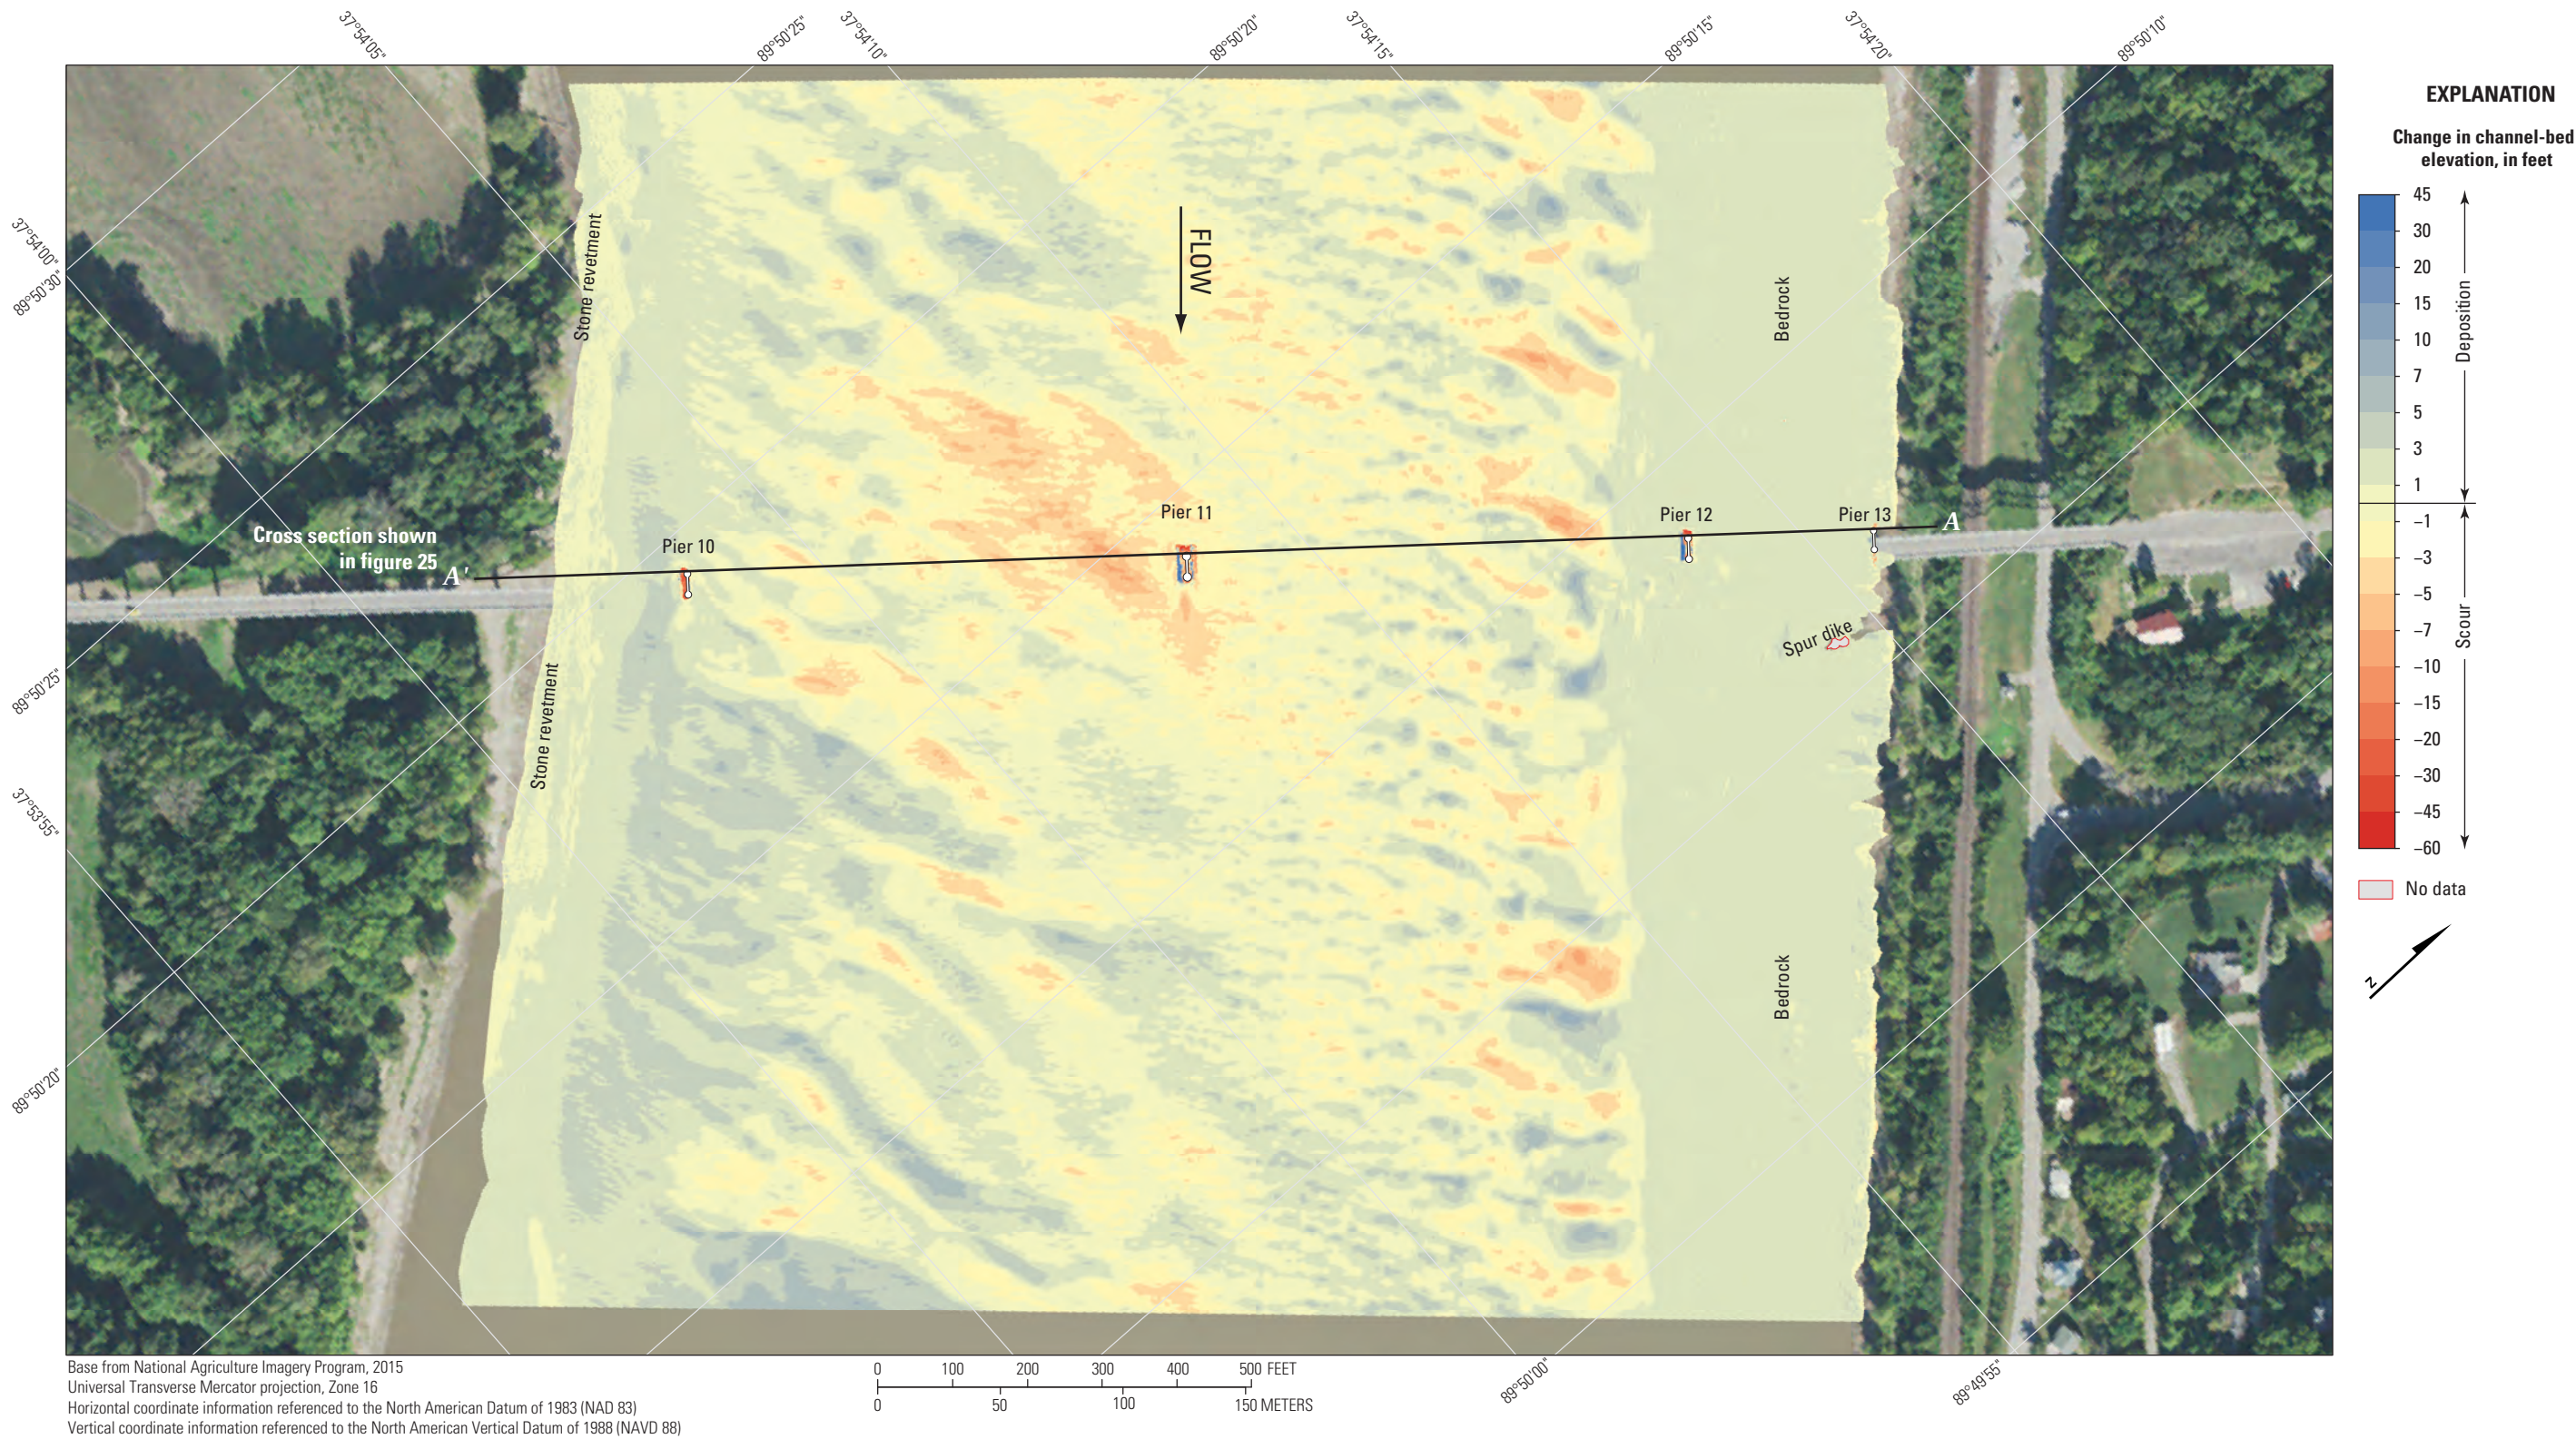
The difference between the survey on July 24, 2018, and the previous survey on June 9, 2014 (fig. 26), indicates minor overall deposition from 2014 to 2018, as indicated by an average difference of +0.72 ft between the bathymetric surfaces (table 8). The net volume of cut in the reach from 2014 to 2018 was about 57,200 yd<sup>3</sup>, and the net volume of fill was about 136,300 yd<sup>3</sup>, resulting in a net gain of about 79,100 yd<sup>3</sup> of sediment. There was an area of scour near pier 11, and some localized scour of as much as 10 ft in various locations throughout the middle of the channel; however, moderate deposition of as much as 10 ft was present throughout the rest of the reach, including as much as 3 ft of apparent deposition

**Figure 26.** Difference between surfaces created from bathymetric surveys of the Mississippi River near structure L0135 on State Highway 51 at Chester, Illinois, on July 24, 2018, and June 9, 2014.

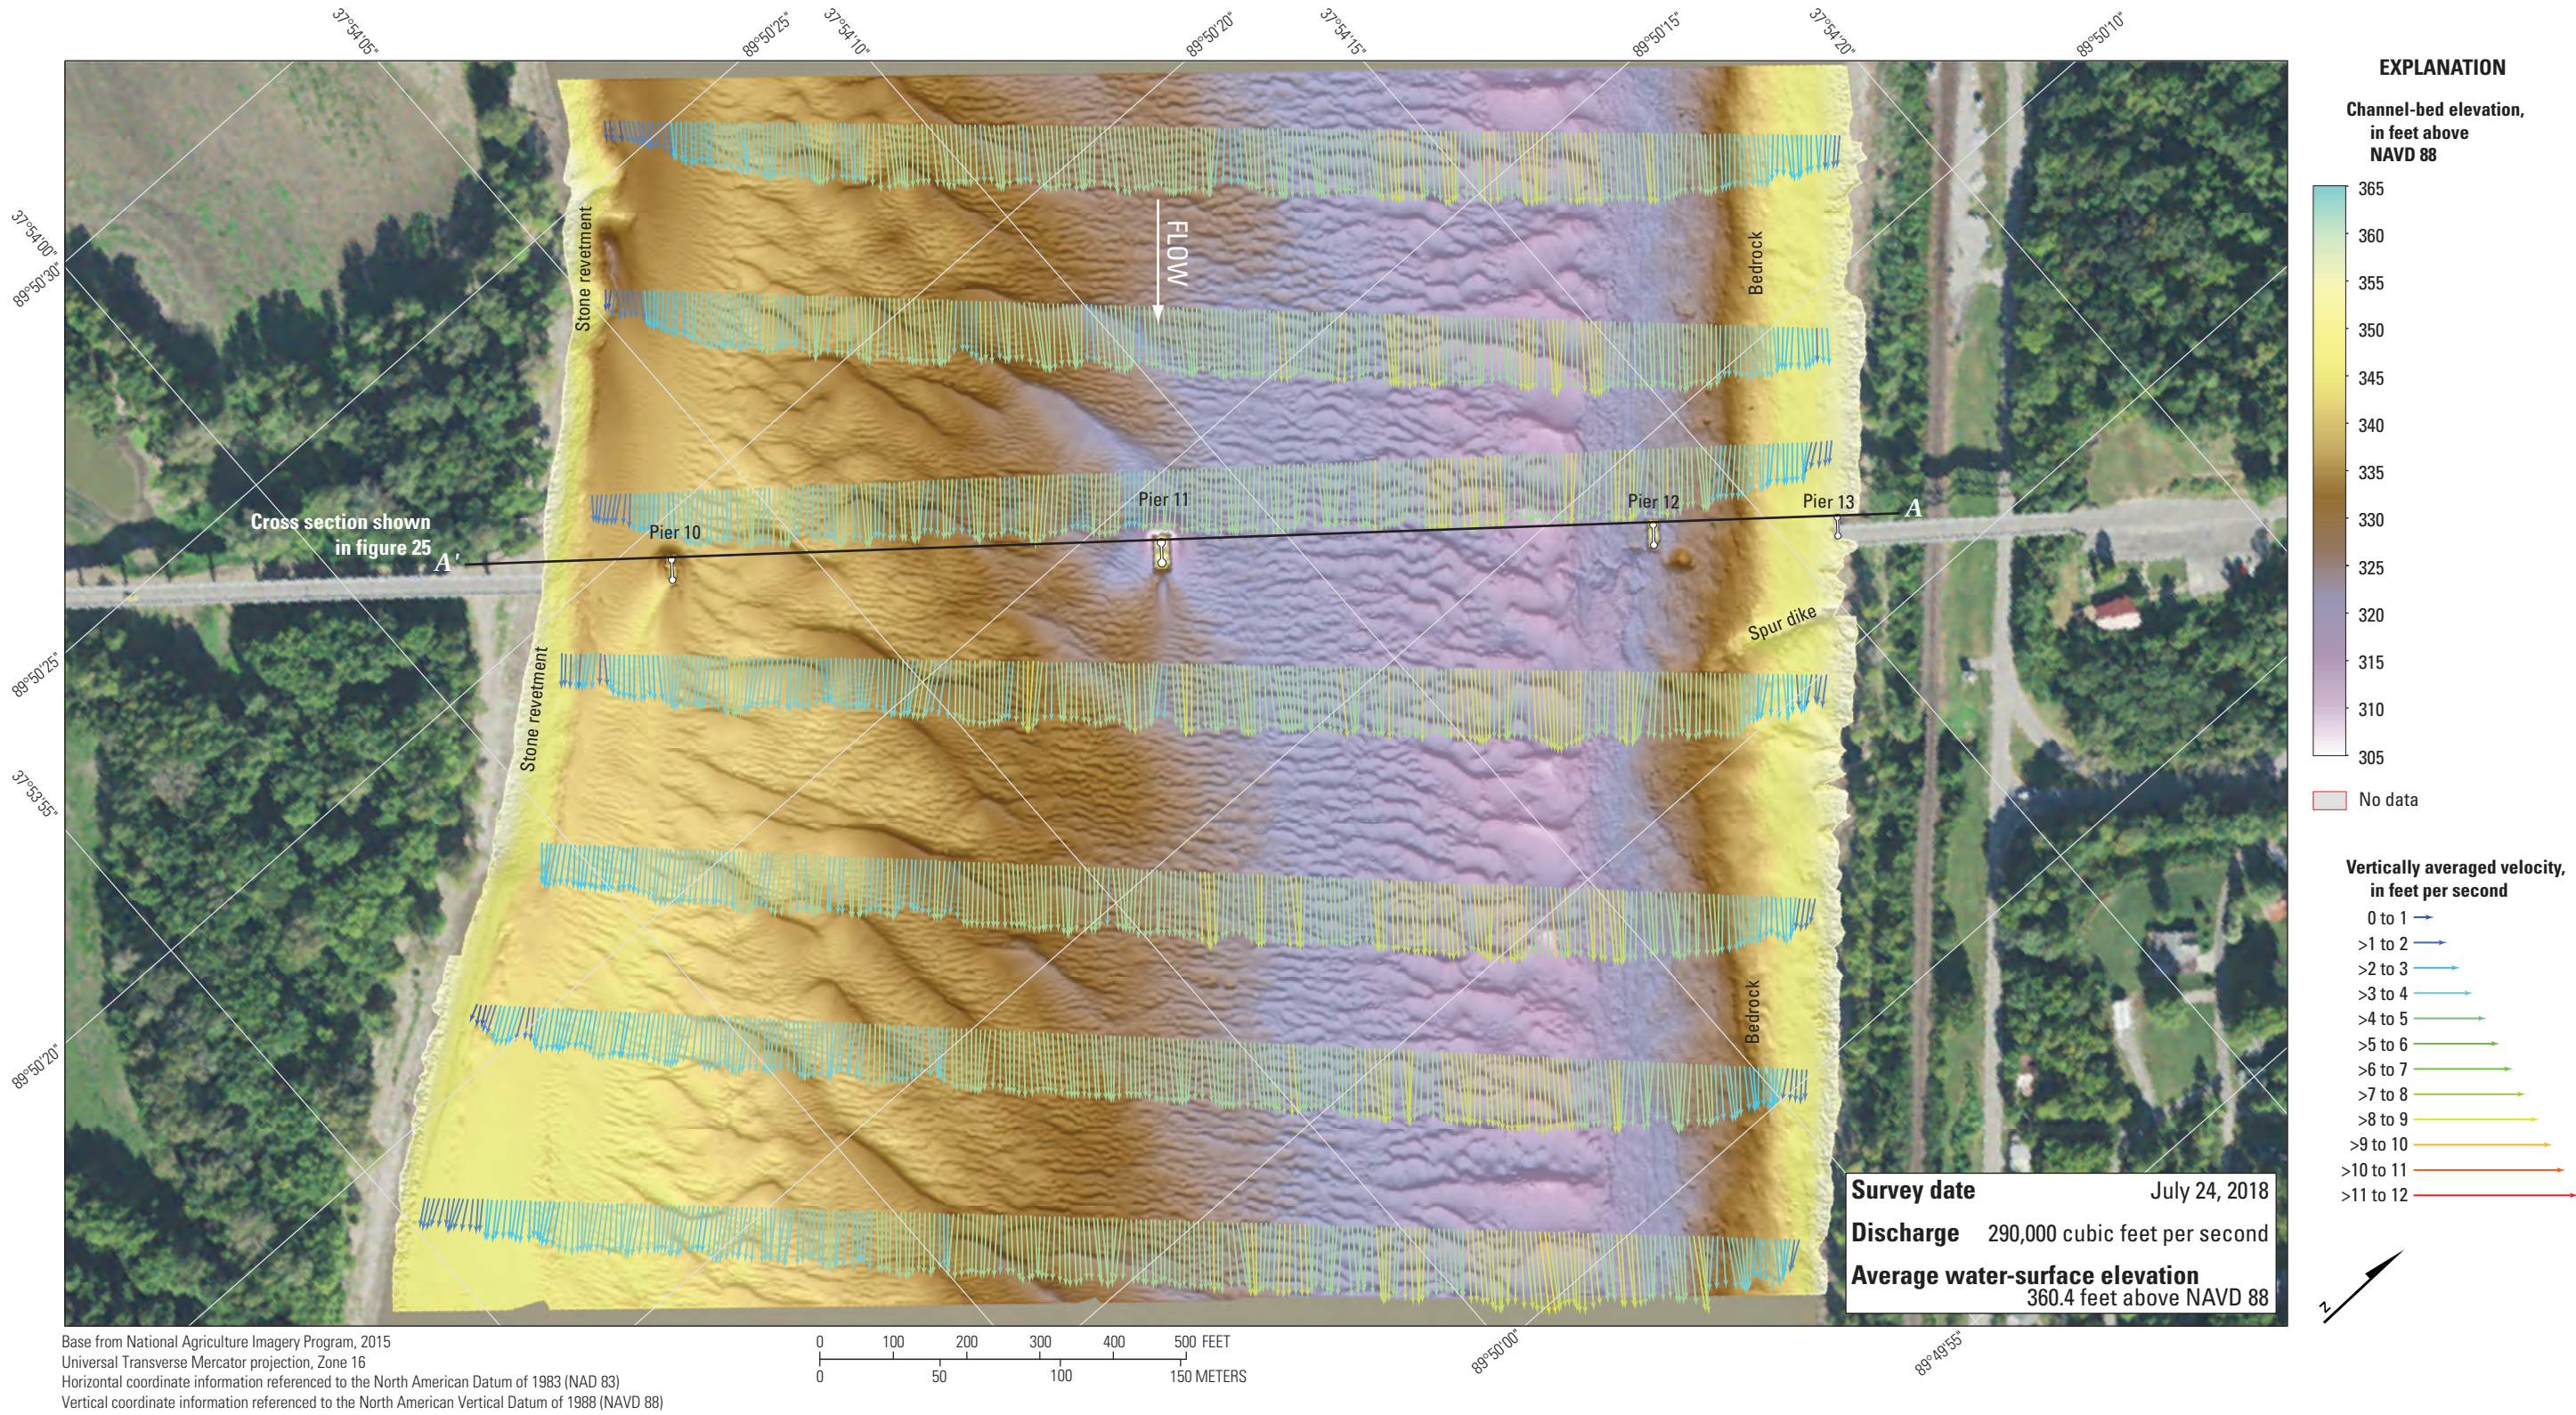
The vertically averaged velocity vectors indicate mostly uniform, expanding flow throughout most of the reach, ranging from about 2 to 9 ft/s, with areas of shear along the right side of the channel (fig. 27). All the piers were aligned with flow, as indicated by little to no turbulence observed downstream that can be directly attributed to the piers (fig. 27).

**Figure 27.** Bathymetry and vertically averaged velocities of the Mississippi River near structure L0135 on State Highway 51 at Chester, Illinois.

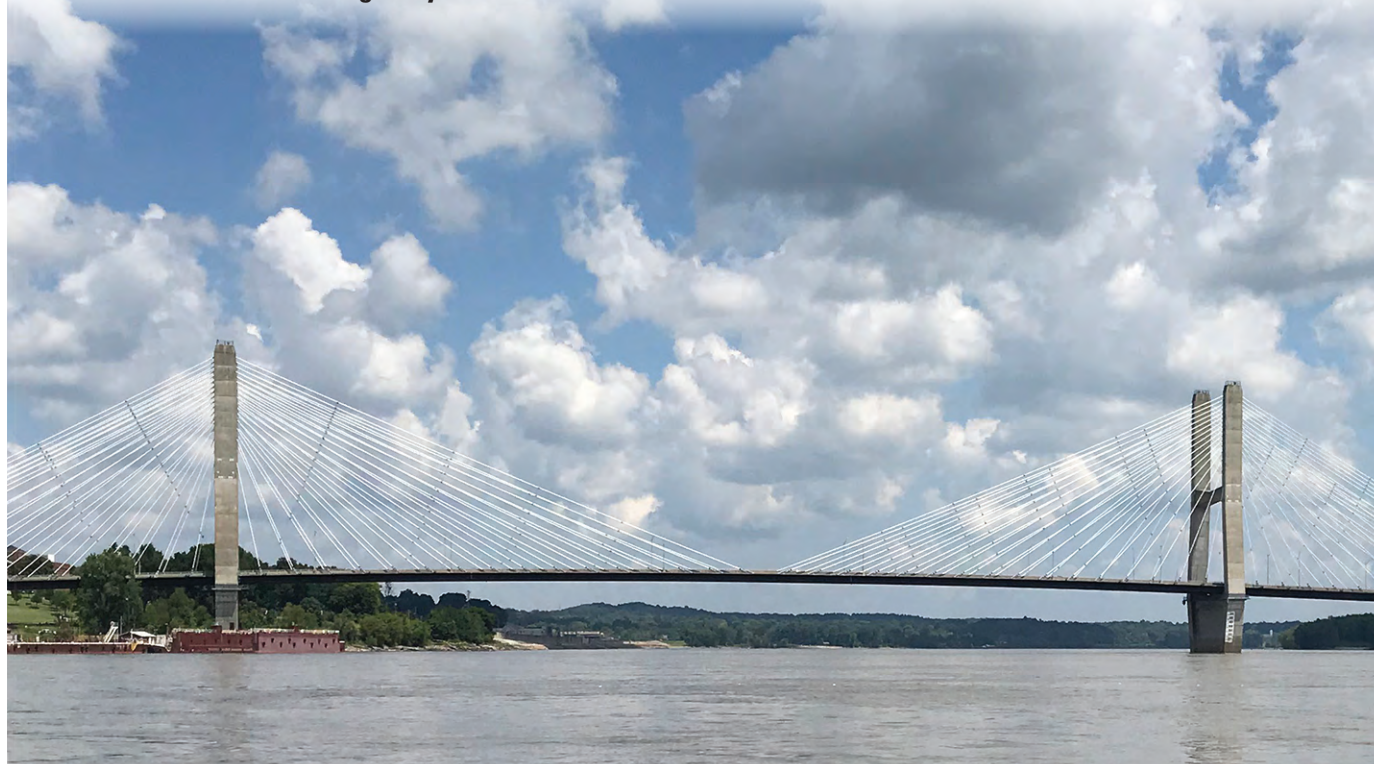
**Structure A5076 on State Highway 34**

Piers 3 and 4 seemed to be partially surrounded by piles of riprap or rock (figs. 28, 1.6E through 1.6H), with additional scour downstream from the piers reaching a minimum elevation of 270 ft near pier 3 and 285 near pier 4 (fig. 28; table 7). Poorly defined, minor scour holes were observed near piers 5 and 6 (figs. 28, 1.6A through 1.6D), having a minimum channel-bed elevation of about 300 ft at pier 5 and 311 ft at pier 6 (table 7); however, the top of the footing was visible at pier 5, and the top of the distribution cap was visible at piers 3 and 4 (figs. 28, 30). The minimum channel-bed elevation near pier 5 is about 15 ft above the elevation of the bottom of the pier seal course of 285.00 ft, and the minimum channel-bed elevation near pier 6 is about 19 ft above the elevation of the bottom of the pier seal course of 292.00 ft (fig. 30; table 7). Information from bridge plans (Missouri Department of Transportation, written commun., 2014) indicates that piers 3 and 4 are founded on caissons on bedrock, having about 20 ft of bed material between the bottom of the scour hole and bedrock at pier 3, and 41 ft of material at pier 4. Piers 5 through 7 are founded on shafts drilled as much as 22 ft into bedrock, having about 55 ft of bed material between the bottom of the scour hole and bedrock at pier 5, and about 66 ft of material at pier 6 (fig. 30; table 7). The surveyed bed generally was similar to the previous survey in 2014, and the original ground line in 1996 from bridge plans, except near pier 4 (fig. 30).

The vertically averaged velocity vectors indicate mostly uniform flow throughout the thalweg of the channel along the right bank, ranging from about 5 to 9 ft/s with minor variations in velocity across the sections (fig. 32). Moderate non-uniform flow was observed along the left side of the channel, particularly downstream from the spur dike on the left bank. Piers 3 and 4 were skewed to approach flow, causing substantial wake vortices with flow reversal and well-defined deposition ridges downstream (figs. 28, 32)

Figure 28. Bathymetric survey of the Mississippi River channel near structure A5076 on State Highway 34 at Cape Girardeau, Missouri.

either side that may be partial riprap blankets (fig. 18), and piers 3 and 4 of structure A5076 at Cape Girardeau, Mo. (site 37, fig. 1), seemed to be partially surrounded with piles of coarse material (fig. 28). However, the effectiveness of the scour mitigation is uncertain, because the placement seems random and non-uniform. Furthermore, there are no indications of designed scour countermeasures at these sites in the bridge plans. Scour immediately downstream from piers 3 and 4 of structure A5076 at Cape Girardeau, Mo., was substantial (fig. 28), but likely does not directly affect the stability of those piers.

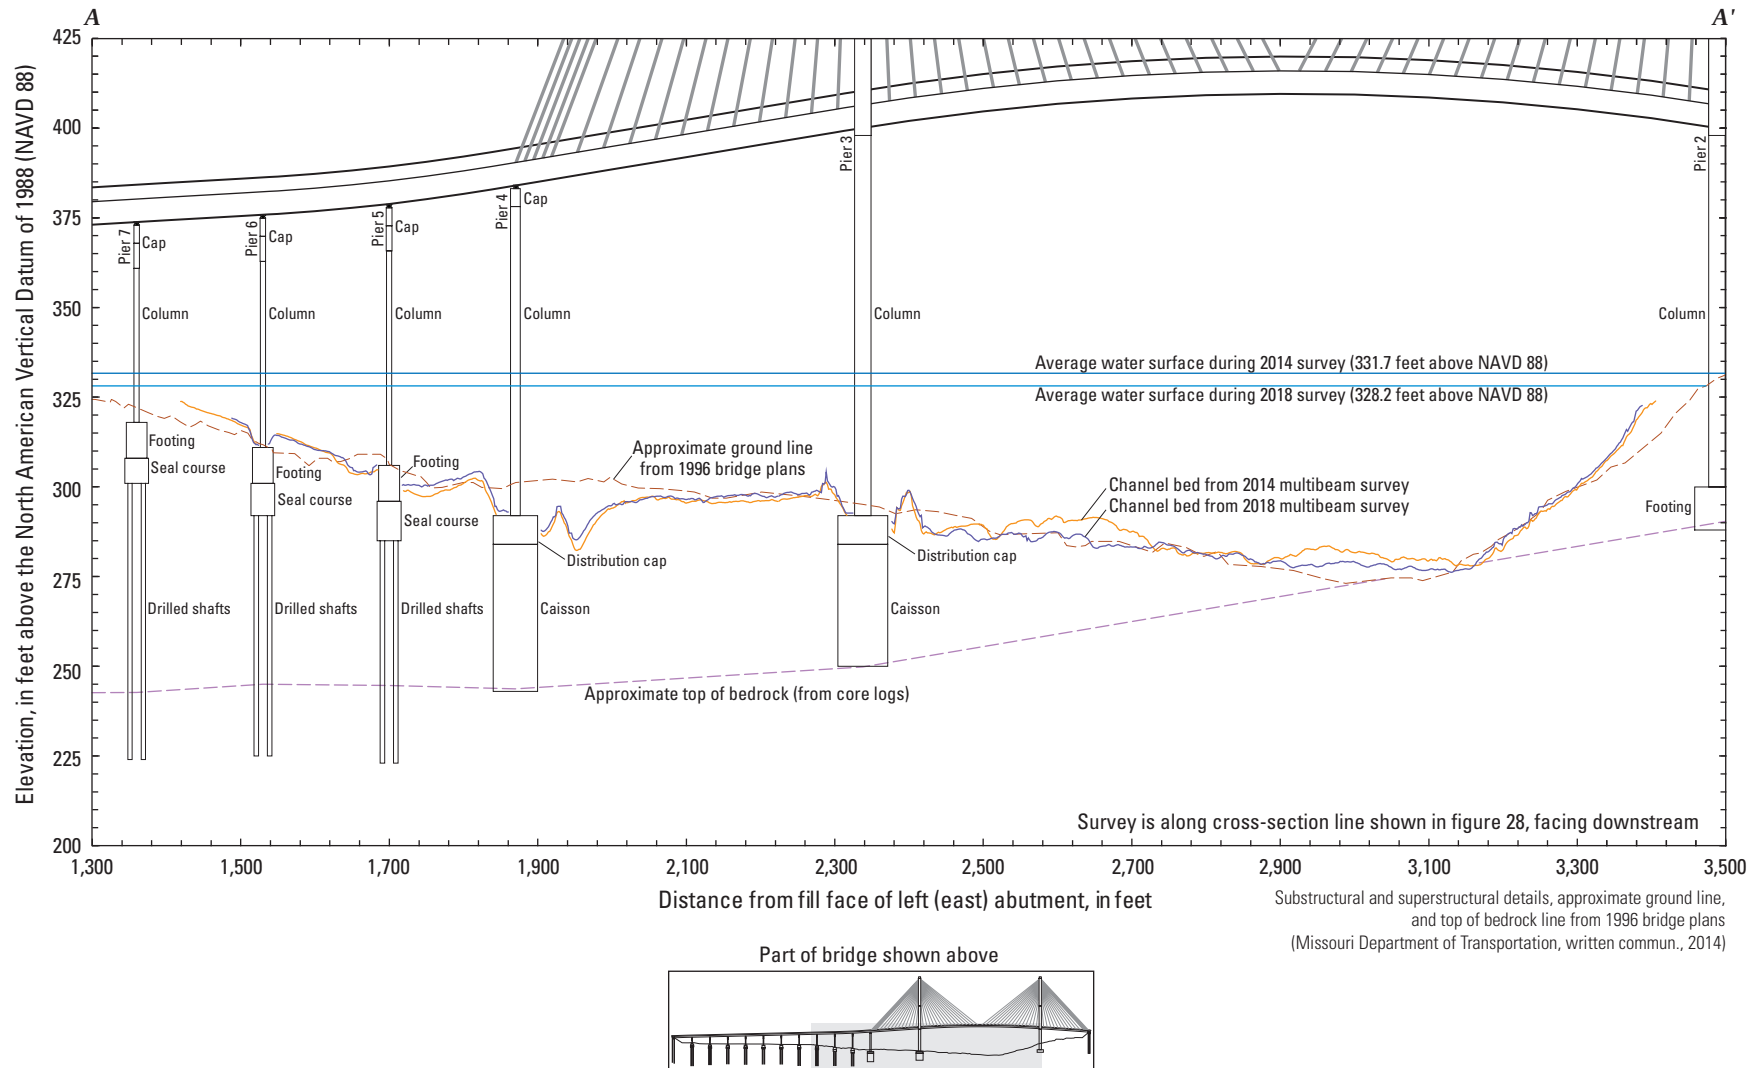
**Figure 30.** Key features, substructural and superstructural details, and surveyed channel bed of structure A5076 on State Highway 34 crossing the Mississippi River at Cape Girardeau, Missouri.

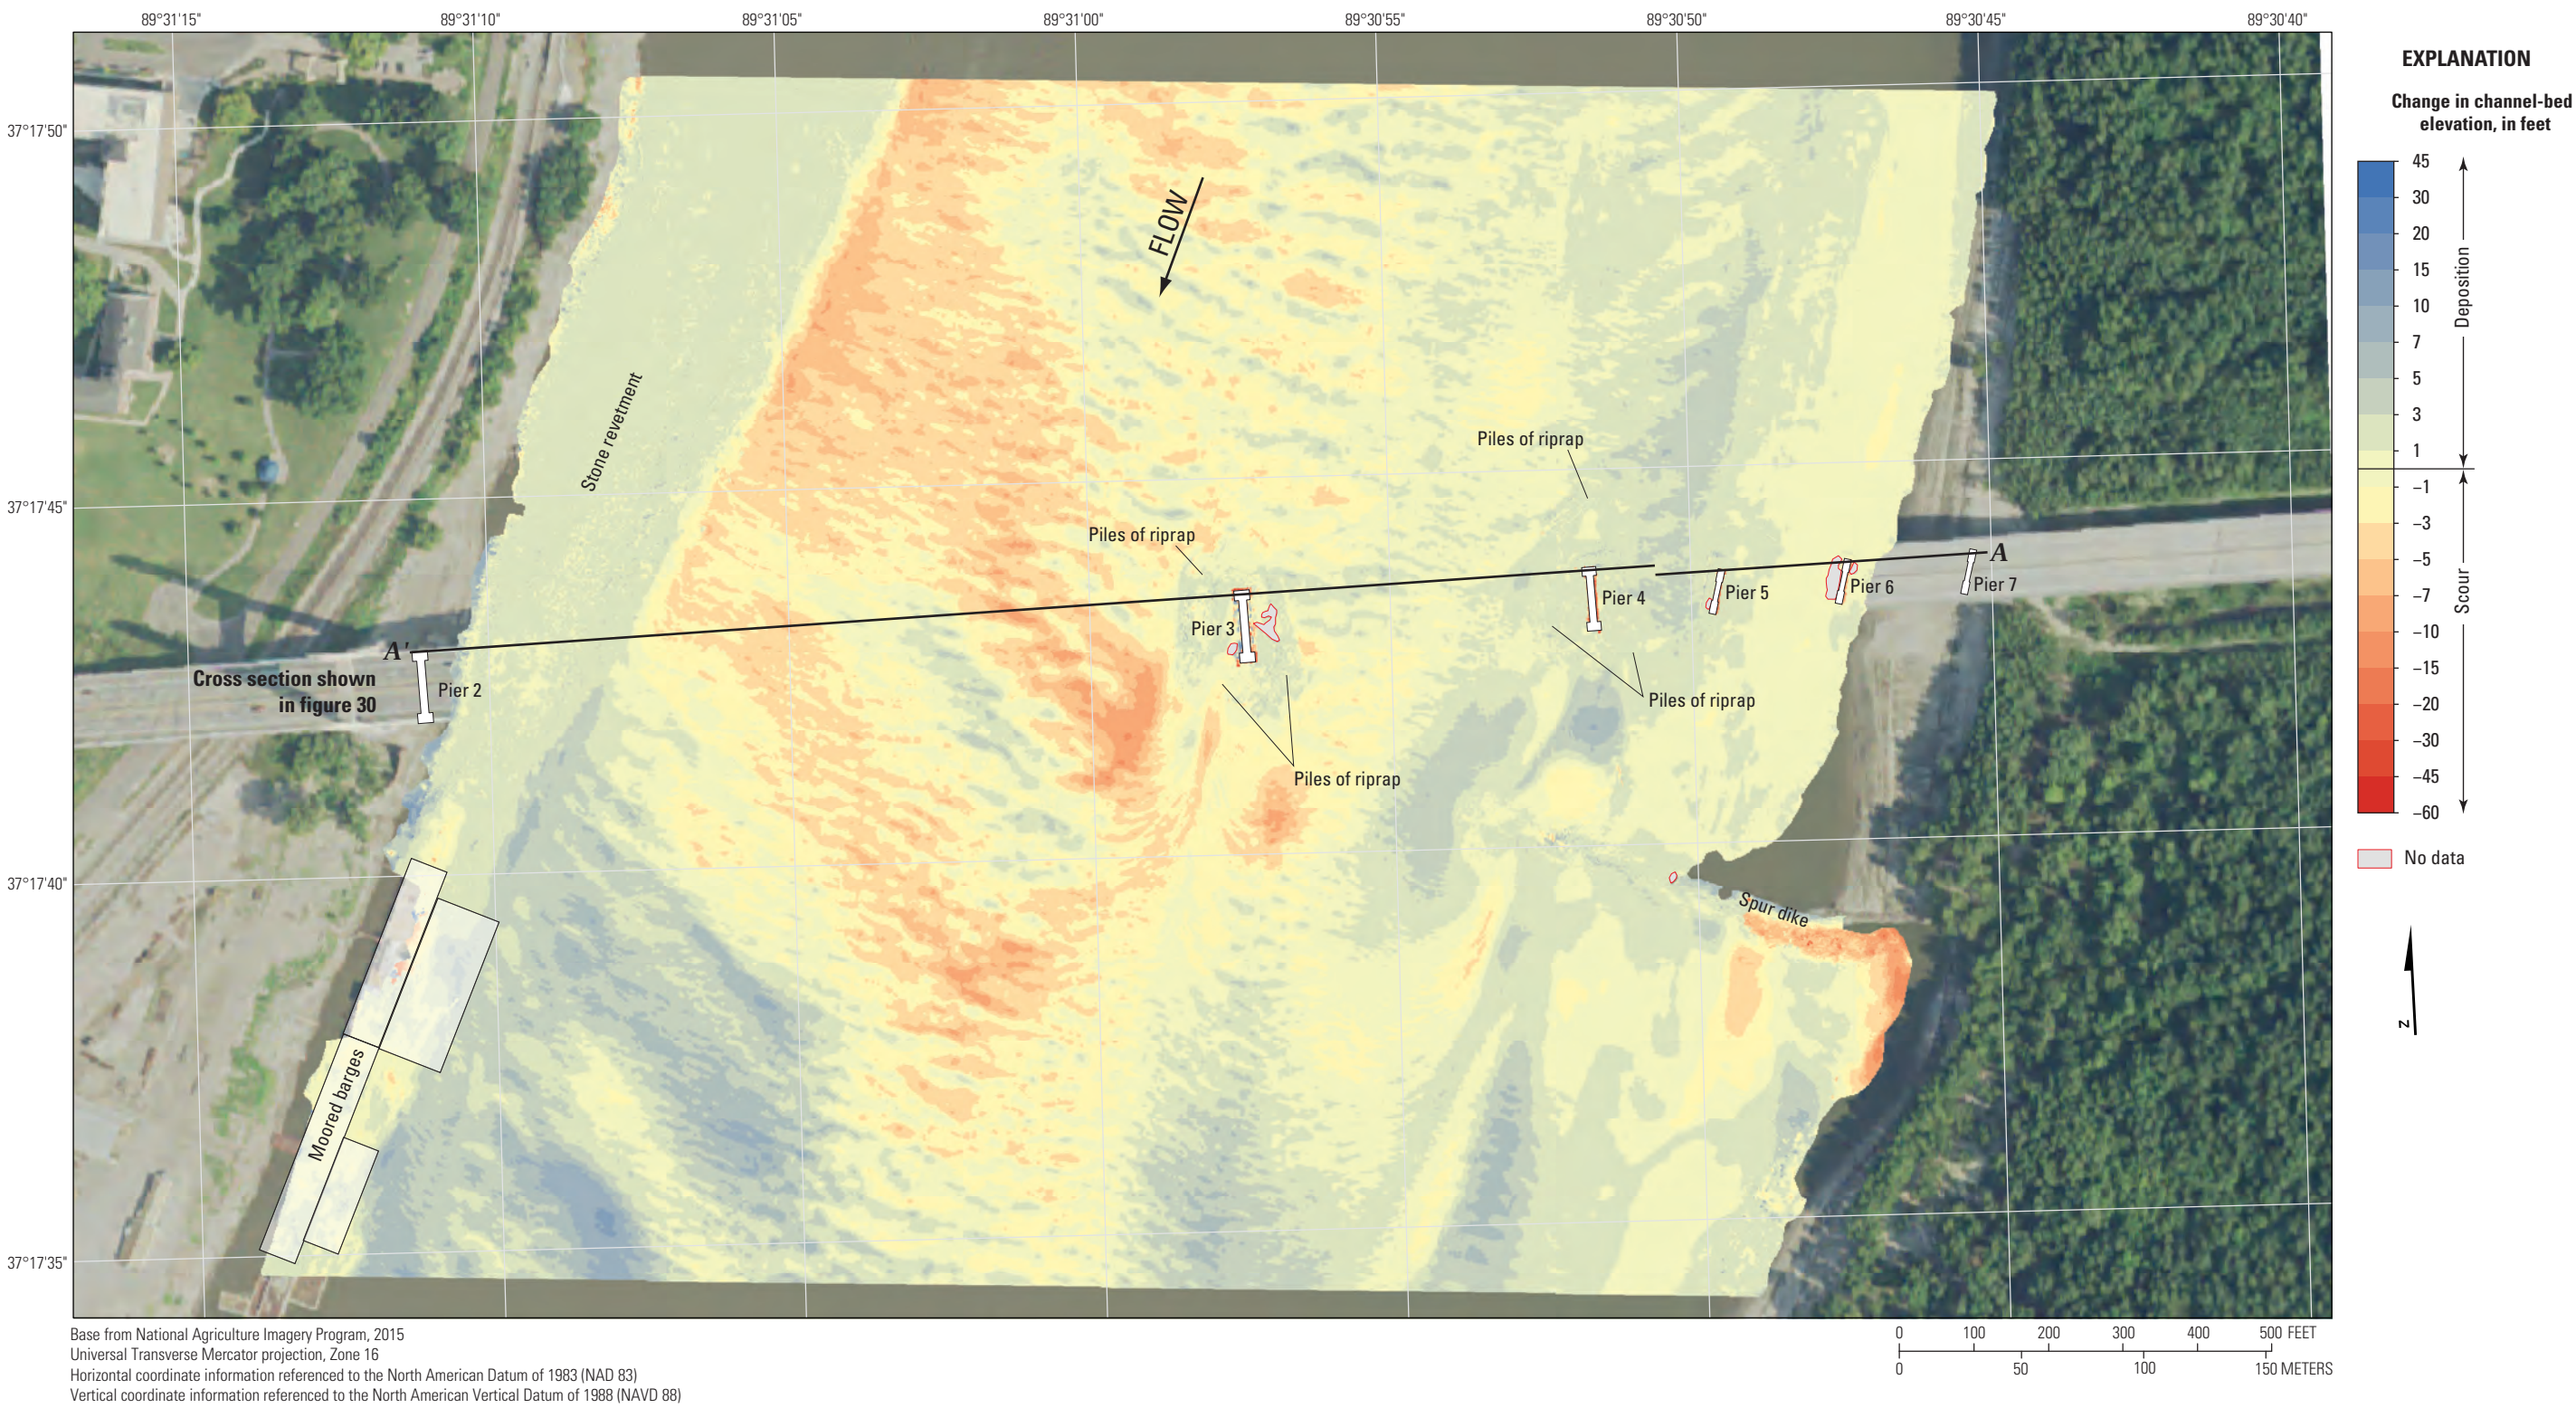
The difference between the survey on July 25, 2018, and the previous survey on June 10, 2014 (fig. 31), indicates a general balance between scour and deposition (an average difference of +0.21 ft between the bathymetric surfaces) throughout the reach from 2014 to 2018 (table 8). The net volume of cut in the reach from 2014 to 2018 was about 108,300 yd<sup>3</sup>, and the net volume of fill was about 132,400 yd<sup>3</sup>, resulting in a net gain of about 24,100 yd<sup>3</sup> of sediment. Scour was observed in the upstream right and downstream middle of the channel, and downstream from the spur dike on the downstream left bank (fig. 31). Minor deposition was observed on the stone revetment on the upstream right side of the channel, and moderate deposition of as much as 7 ft was observed along the toe of the right bank downstream, as well as along the left side of the

**Figure 31.** Difference between surfaces created from bathymetric surveys of the Mississippi River channel near structure A5076 on State Highway 34 at Cape Girardeau, Missouri, on July 25, 2018, and June 10, 2014.
